Manhole Inspection Summary

Manhole # S03AA2011MH

Location Address: **6100 CROSS COUNTRY BLVD** Cross Street: **TANEY RD**

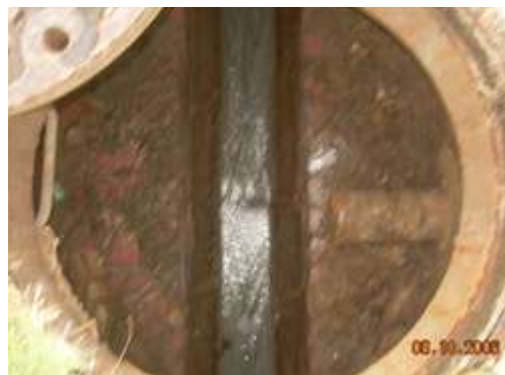
Top View

Bench debris.

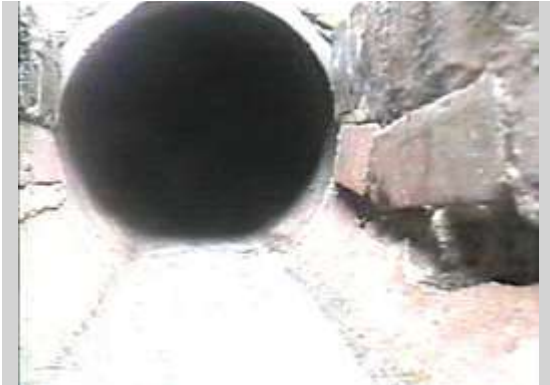
12 in. Circular Gravity Sewer Pipe Out @ 12 O'Clock

Comments **I3 pipe picture shows Barrel infiltration. Both the O12 and the I6 pipe pictures show Channel deterioration. The I6 pipe picture shows Corbel infiltration.**

Channel Material: **Clay** ☐ Parged ☐ Debris (not Condition related)
Channel Exposure: **Fully Open** Junc Dist: **0** nearest .5 ft. Azimuth:
Condition: ☐ Sound ☐ Cracked ☐ Root Intrusion ☒ **Deteriorated** ☐ Leaks ☐ Debris

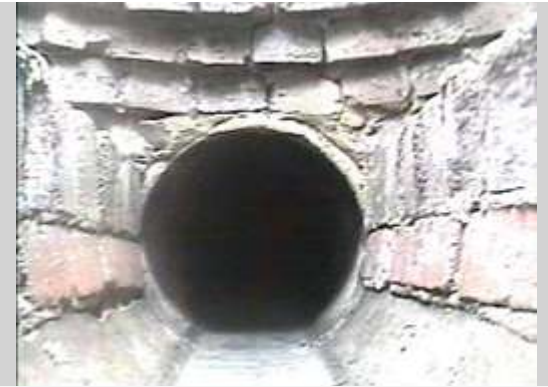
Pipe In @ 6 O'Clock

Corbel Material: **Brick** ☐ Parged Type: **Concentric/Eccentric**
Condition: ☒ Sound ☐ Cracked ☐ Root Intrusion ☐ Loose Brick ☐ Deteriorated
Infiltration: ☐ None ☒ **Joint** ☐ Cracks ☒ **Mortar** ☐ Roots ☐ Wall

Pipe Seal Cond: **Cracked**
